# Manhole Inspection Summary

Manhole # S39MM\_008MH

Insp Date: **2/5/07 1:10 PM**

**Location** Address: **2000 KENNEDY AVE**

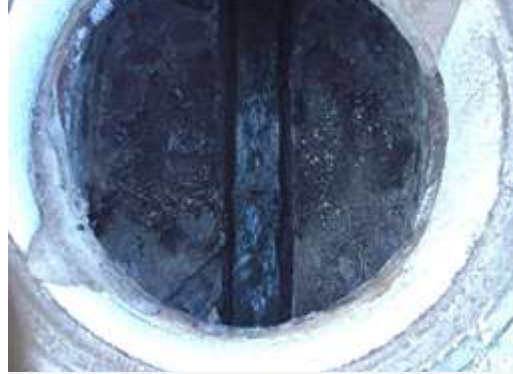
Top View

**Frame** Offset: **0** (in.) Condition: ☐ Sound ☐ Cracked ☒ **Leaks**

**Bench** ☒ Exists Material: **Brick** ☐ Parged ☒ **Debris** (not Condition related)

**Surcharge** ☒ **Evidence Of Surcharge** Depth: **1** (ft.) ☐ Active Surcharge Present

Frame leaks. Evidence of surcharge - Bench debris.

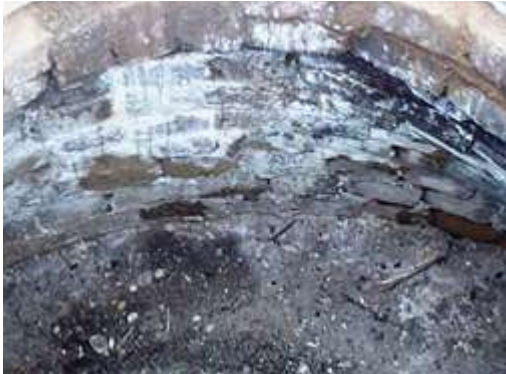
Defect

Condition: ☐ Sound ☐ Cracked ☐ Root Intrusion ☐ Loose Brick ☒ **Deteriorated**

Infiltration: ☐ None ☒ **Joint** ☐ Cracks ☐ Mortar ☐ Roots ☒ **Wall**

Infiltration: ☐ None ☐ Joint ☐ Cracks ☐ Mortar ☐ Roots ☒ **Wall**

Infiltration: ☐ None ☐ Joint ☐ Cracks ☒ **Mortar** ☐ Roots ☒ **Wall**

Adjustment and Barrel deterioration and infiltration. Corbel infiltration.

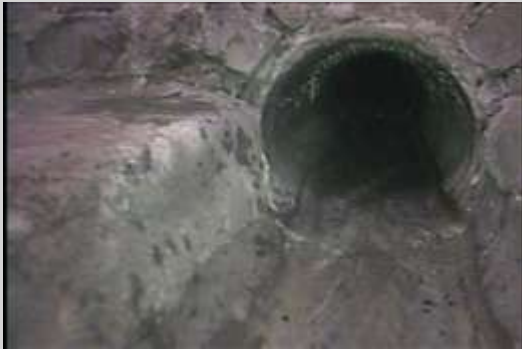
### 8 in. Circular Gravity Sewer Pipe Out @ 12 O'Clock

Invert Depth: **4.20** (ft.) Flow Characteristics: **Slow**

Infiltration: **None** Pipe Seal Cond: **Unknown**

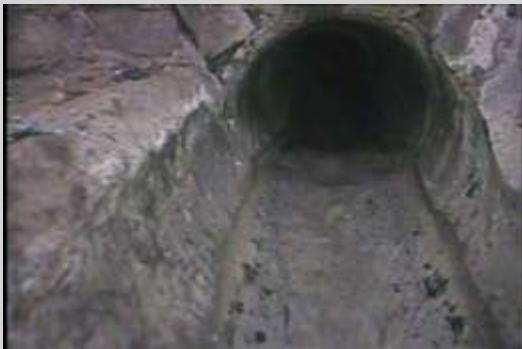
### 8 in. Circular Gravity Sewer Pipe In @ 6 O'Clock

Invert Depth: **4.15** (ft.) Flow Characteristics: **Slow**

Infiltration: **None** Pipe Seal Cond: **Unknown**

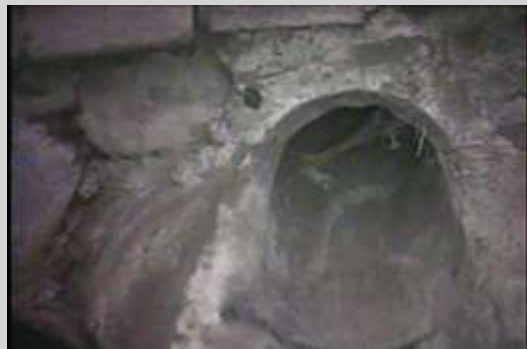
6 in. Circular Gravity Sewer

Invert Depth: **3.55** (ft.) Flow Characteristics: **None**

Infiltration: **Evidence**
